WA21-546K

HOLDEN COLORADO RG / ISUZU DMAX

UPPER BALL JOINT SPACER

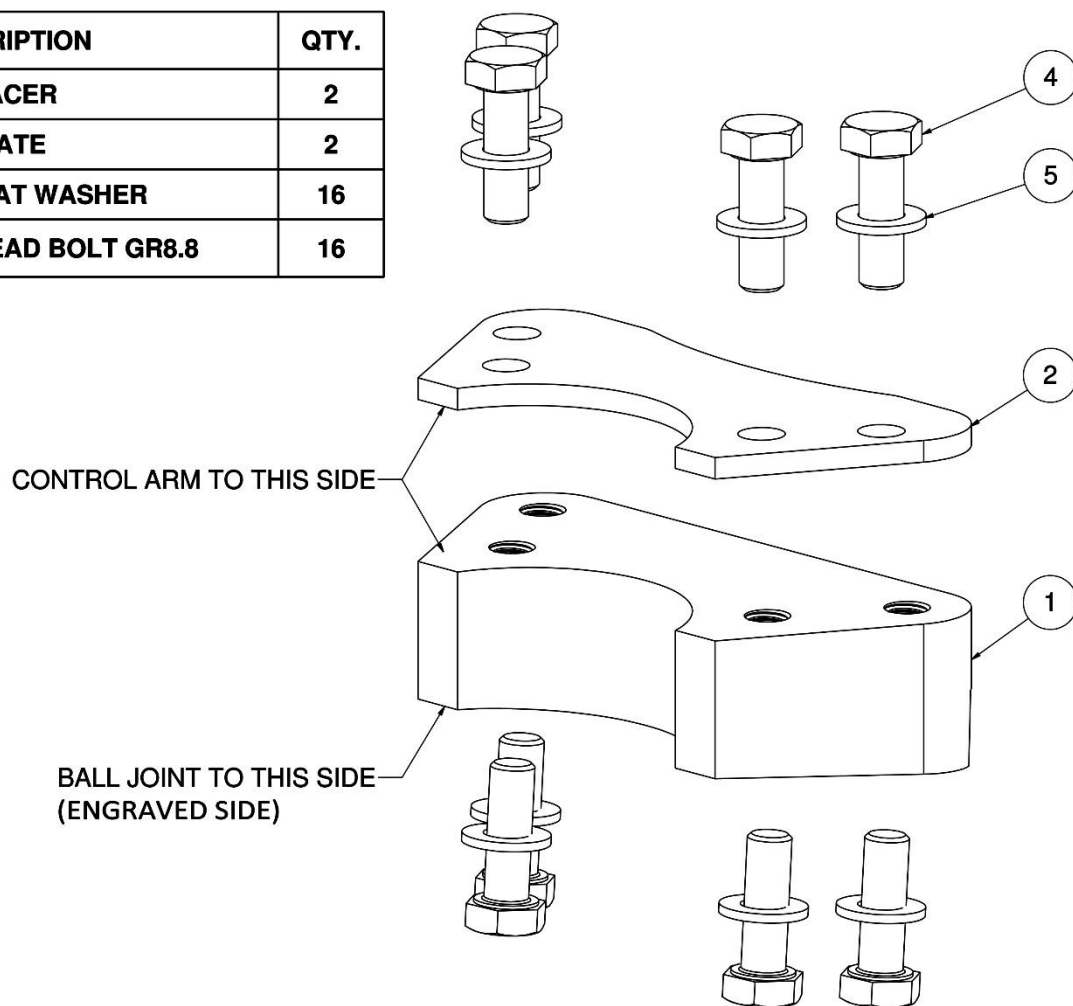
The WA21-546k upper balljoint spacer is designed to fix a range of issues when lifting these vehicles beyond 2 inches. The spacer allows the suspension to droop further by preventing ball joint bind, preventing the control arm topping out on the steel stopper, prevents CV plunge bind and also helps to rectify negative camber issues. A Diff drop kit **MUST** be fitted in conjunction with these spacers. With the vehicle safely jacked off the ground, secured with stands and the spring & strut removed, secure the lower control arm with a jack and remove the upper control arm balljoint from the spindle. Install the spacer between the ball joint and the control arm with the ball joint located to the "ball joint" side engraved on the spacer. The thinner load distributing plate locates on top of the control arm. Apply Loctite thread lock to ALL bolts, use the washers supplied and tighten bolts. Re-install vehicle suspension and check all fixings are tight. Vehicle will require wheel alignment once finished.
